Manhole Inspection Summary

Manhole # S41U__025MH

Insp Date: **7/28/09 7:20 AM**

Location Address: **1401 WOODALL ST**

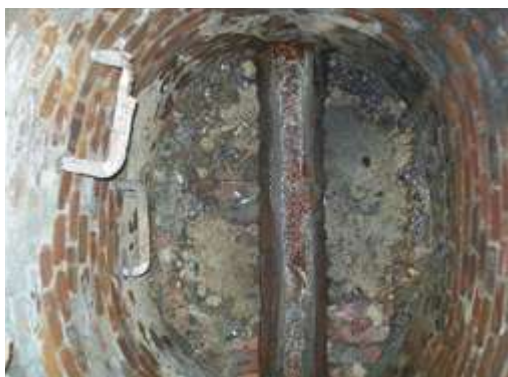
Defect 2

Condition: ☐ Sound ☐ Cracked ☐ Root Intrusion ☐ Deteriorated ☐ Leaks ☒ **Debris**

DEBRIS ON BENCH

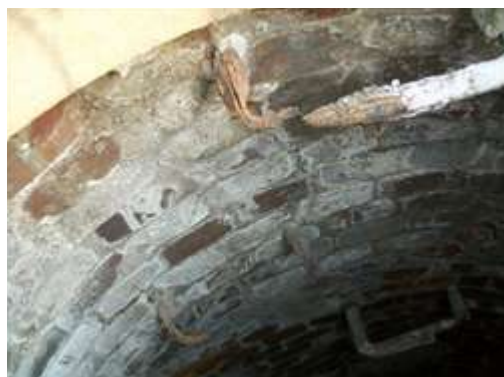
Defect 1

Steps Count: **4** Missing: **2** ☒ **Corroded**

CORRODED AND MISSING STEPS

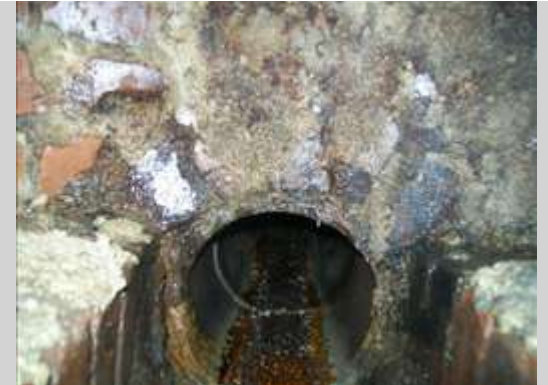
12 O'Clock Outflow

Pipe Height: **8.4** (in.) Rod and Bar (Angled)
Pipe Material: **Clay** ☐ Pipe Lined
Invert Depth: **7.10** (ft.) Flow Characteristics: **Slow**
Deposits: ☒ None ☐ Mud ☐ Sludge ☐ Debris ☐ Grease
Silt Depth: **0** (in.) Deposits Extent:
Infiltration: **None** Pipe Seal Cond: **Sound**

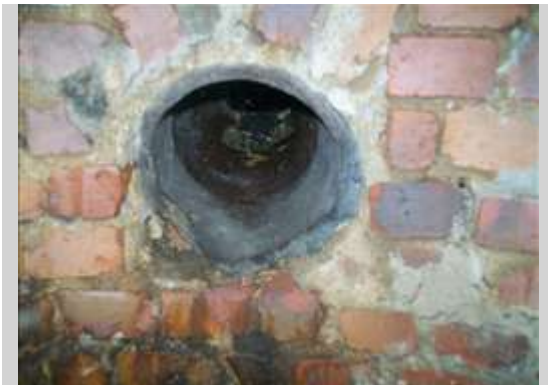
6 O'Clock Inflow

Pipe Height: **8.4** (in.) Rod and Bar (Angled)
Pipe Material: **Clay** ☐ Pipe Lined
Invert Depth: **5.00** (ft.) Flow Characteristics: **Slow**
Deposits: ☒ None ☐ Mud ☐ Sludge ☐ Debris ☐ Grease
Silt Depth: **0** (in.) Deposits Extent:
Infiltration: **None** Pipe Seal Cond: **Sound**

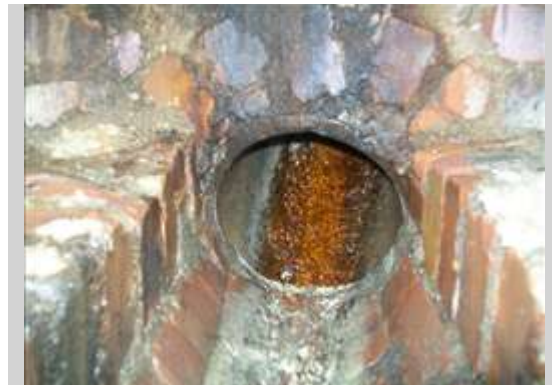
Drop In @ 6 O'Clock

Drop: **Outside** Rod and Bar
Angled: **Yes** Reading: **6.00** (ft.)
Inv Depth: **7.00** (ft.)
Drop Condition: **Open**
